HYDRAULIC-PNEUMATIC FLOATING FENDER - ADDITIONAL IN-SERVICE TESTS, FIRST SERIES

March 1966

U. S. NAVAL CIVIL ENGINEERING LABORATORY PORT HUENEME, CALIFORNIA

Technical Report R-430

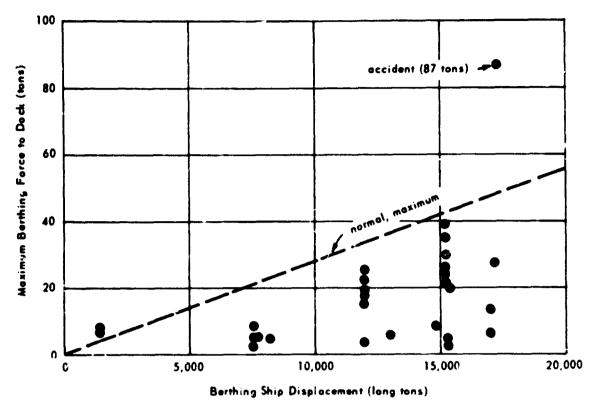
Figure 7. Maximum berthing force to dock.

Bag deflection and force on the fender (Lee, 1963, 1965a), as induced by the berthing ship, were calculated from the measured bag pressures. The maximum impact force varied from about 3 tons for a 1,000-ton ship to 40 tons for a 15,000-ton ship. These are loads of 0.06 and 0.8 tons per lineal foot of berth, which is low compared to the design load of 1.2 tons per lineal foot. An exception was an 87-ton impact force in the accidental berthing of the 17,000-ton USNS General Breckinridge (Figure 7).

It is estimated from Figure 7 that for ships of 20,000 tons displacement the maximum force should not exceed 60 tons for a normal berthing or 100 tons for an accidental berthing; that is, 1,2 or 2,0 tons per linear foot of berth.

- 5. The highest berthing force measurement was 1.7 tons per linear foot of berth, of the dock was not damaged even though its design load is 1.2 tons per linear foot.

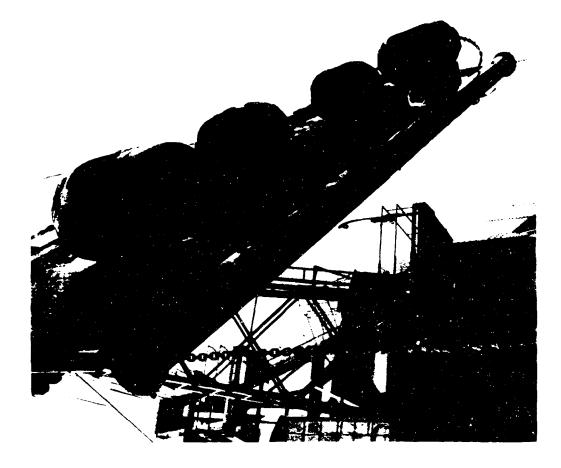
- 1. There was no marine growth above water line (Figure 25), but fouling covered 80% of the exposed area under water.
- 2. The air-filled rubber bags showed no evidence of deterioration. Sides of bags making contact with the bulkhead were abraded slightly by rubbing against the floating bulkhead. All pneumatic rubber bags remained fully symmetrical. The pressure in the two bags of the offshore fender after 1 month was 10 and 12 psi, respectively, while that in the inshore counterpart was 11 psi. (The uniform initial pressure of all bags was 12 psi.)

- 7. There was a light encrustation of barnacles on the lower part of both floating bulkheads.

Figure 25. General condition of the fenders after five months in water. a. No marine growth found above waterline.

b. Moderate marine fouling below waterline.

- 8. The concrete mooring weights were about 90% covered by marine algae and barnacles (Figure 26b).
- 9. The mooring chains showed signs of rusting and about 40% wear at the point where the chain rubs on the 4-inch steel guide pipe. This pipe was broken and flared out at the offshore end.
- 10. Two bolts holding the closure plate to the ballast pipe were loose. There was rust at the base of all pad eyes where they were welded to the ballast pipe.
